Walk Around

TBF/TBM Avenger

Walk Around Number 25
squadron/signal publications

By Lou Drendel

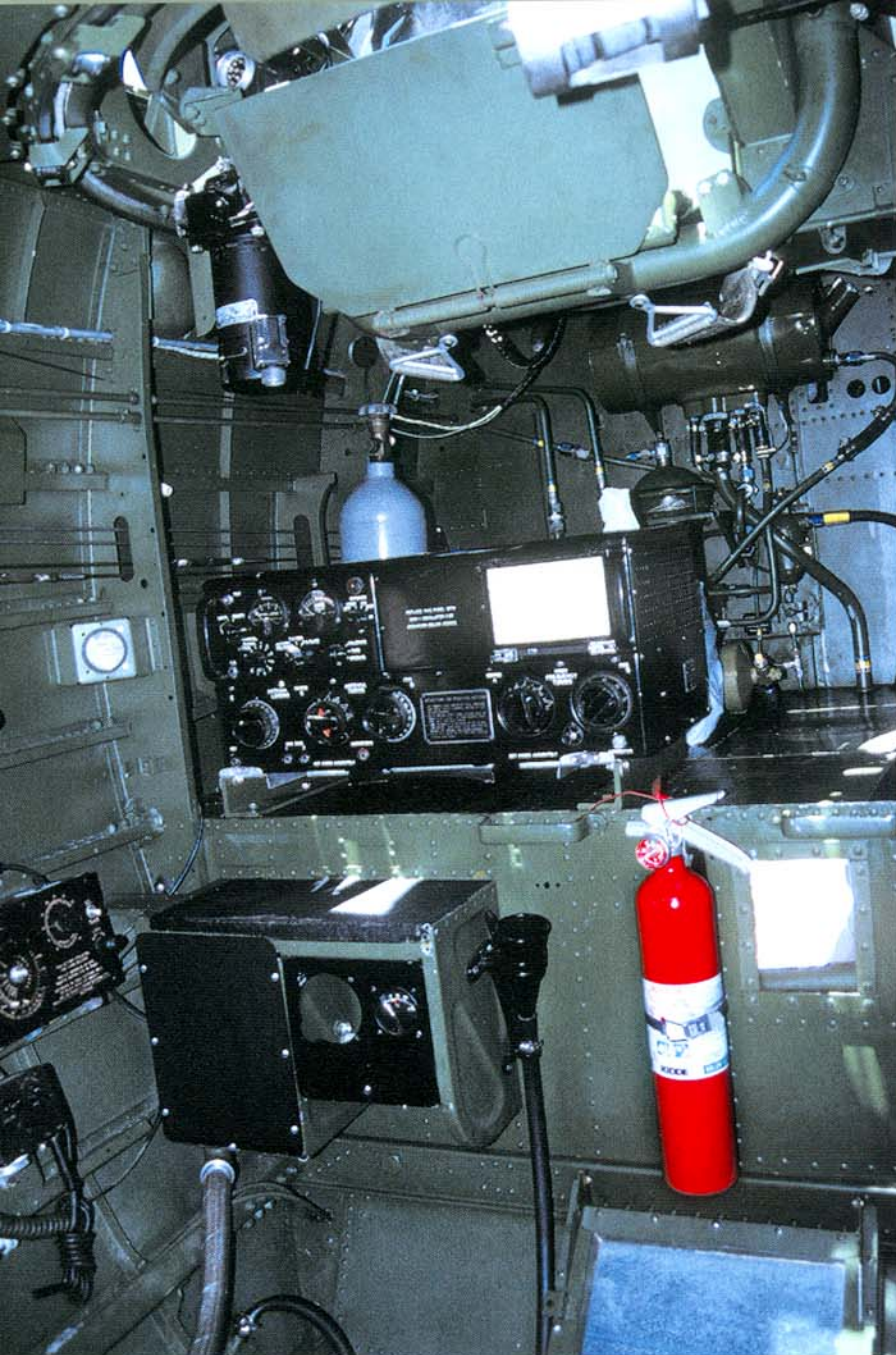
The interior of the Cavanaugh Flight Museum's TBM-3 is nearly flawless in its authentic appearance; however, the period radio equipment in the navigator/bombardier compartment is not operational. The small black box with the crank along the port wall is the intervalometer, which controlled the spacing of bombs released from the bomb bay. The bombardier set this device prior to dropping the ordnance onto the target. The overall interior finish on Eastern-built Avengers was Interior Green (FS34151). (Lou Drendel)

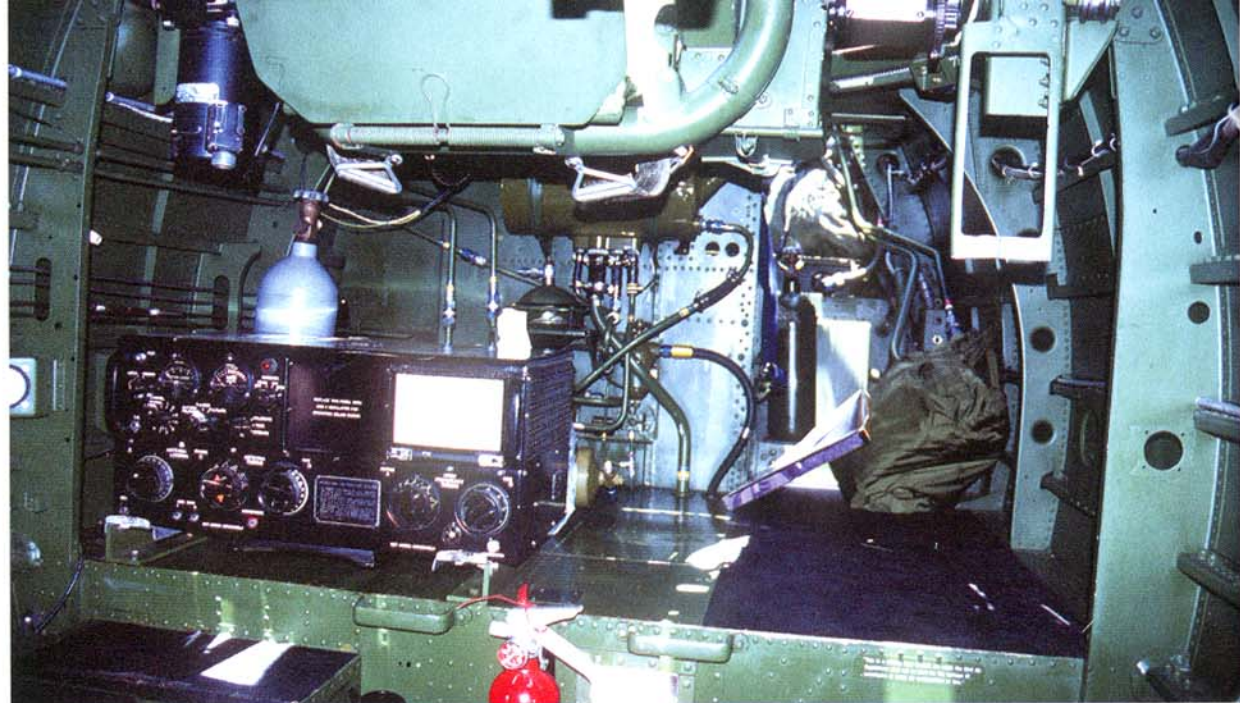
A red fire extinguisher – required modern flight safety equipment – was placed beside the bomb aiming window by the museum's staff. The turret gunner's lower armor plate hung from the turret position in the bombardier compartment's roof. This plate folded up when additional compartment space was needed. The starboard passageway led past the turret to the radio operator's cockpit in the fuselage's midsection. (Lou Drendel)

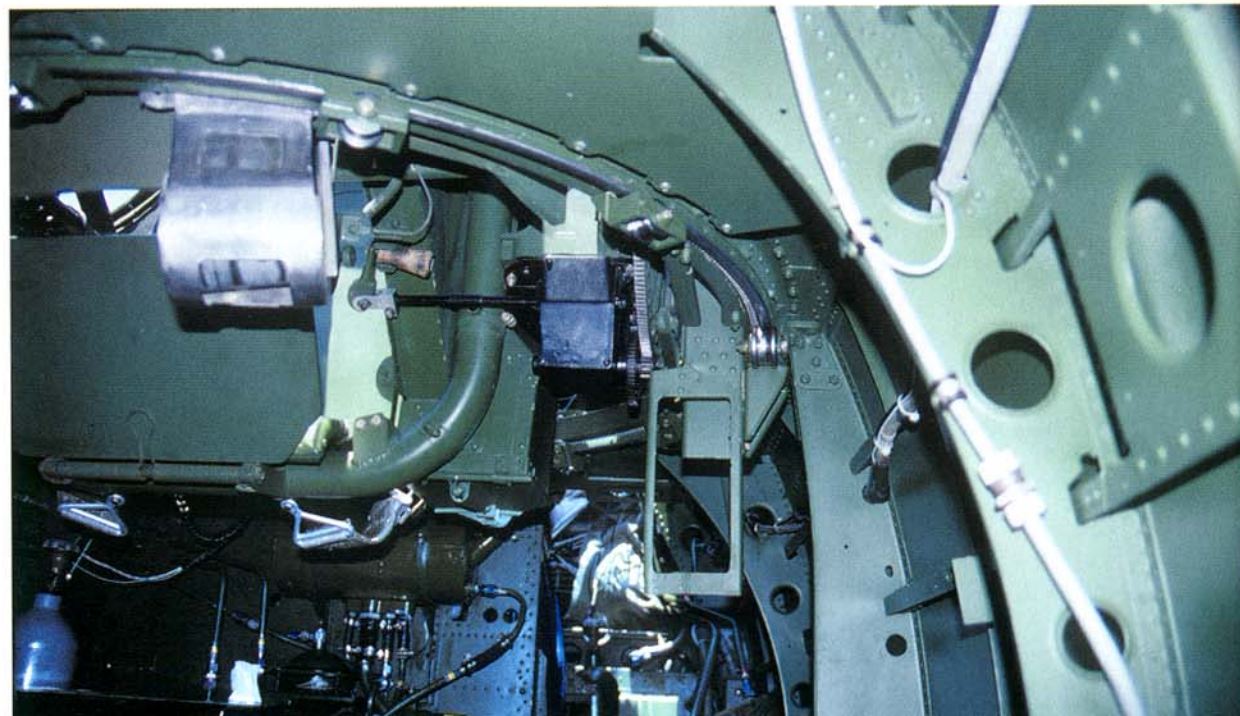
Brown seat belt attachments were fitted to the lower turret assembly. The canvas lap belt secured the gunner to his seat in flight. The step in the center right ceiling assisted the radio operator to climb into his mid fuselage seat. Behind this step is the turret interrupter gear, which was mounted on the turret azimuth ring. This device rotated with the turret and prevented the gunner from accidentally firing on his own aircraft. The interrupter gear replaced a cutout gear fitted to early Avengers. (Lou Drendel)

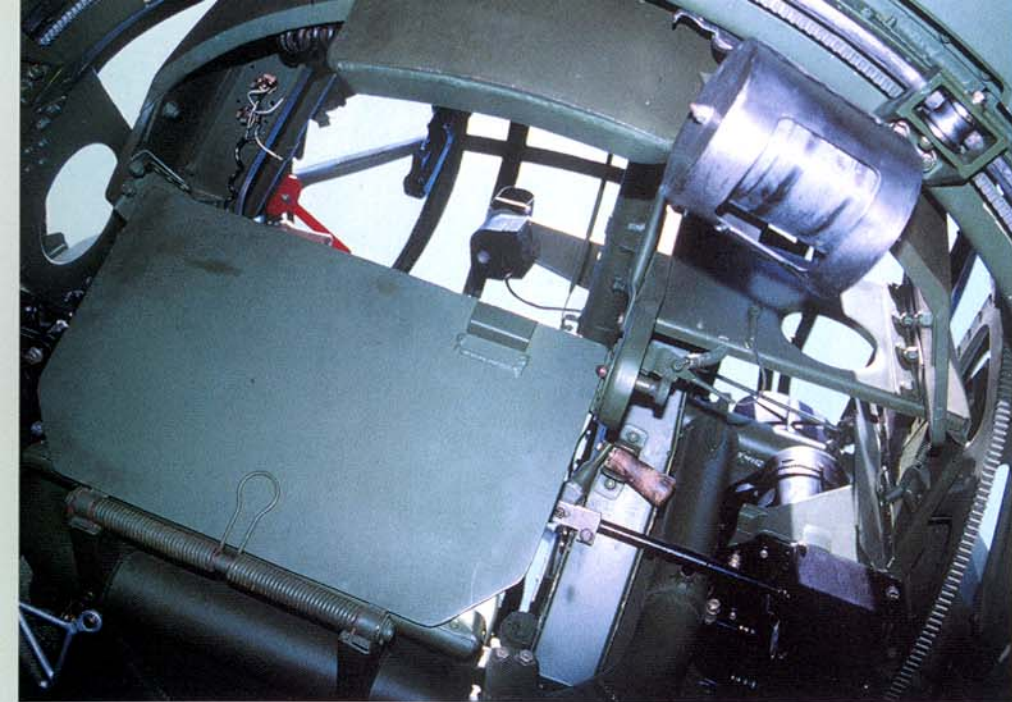
The .75 inch (19.1mm) thick lower armor plate served as a footrest for the turret gunner. His seat was also armor plated for protection from bullets and cannon shells. The silver cylinder beside the turret ring was one of the two electric motors used to revolve and elevate the turret. The turret's electric motors employed the Amplidyne form of control, which governed both the torque and speed of a motor with great precision. (Lou Drendel)

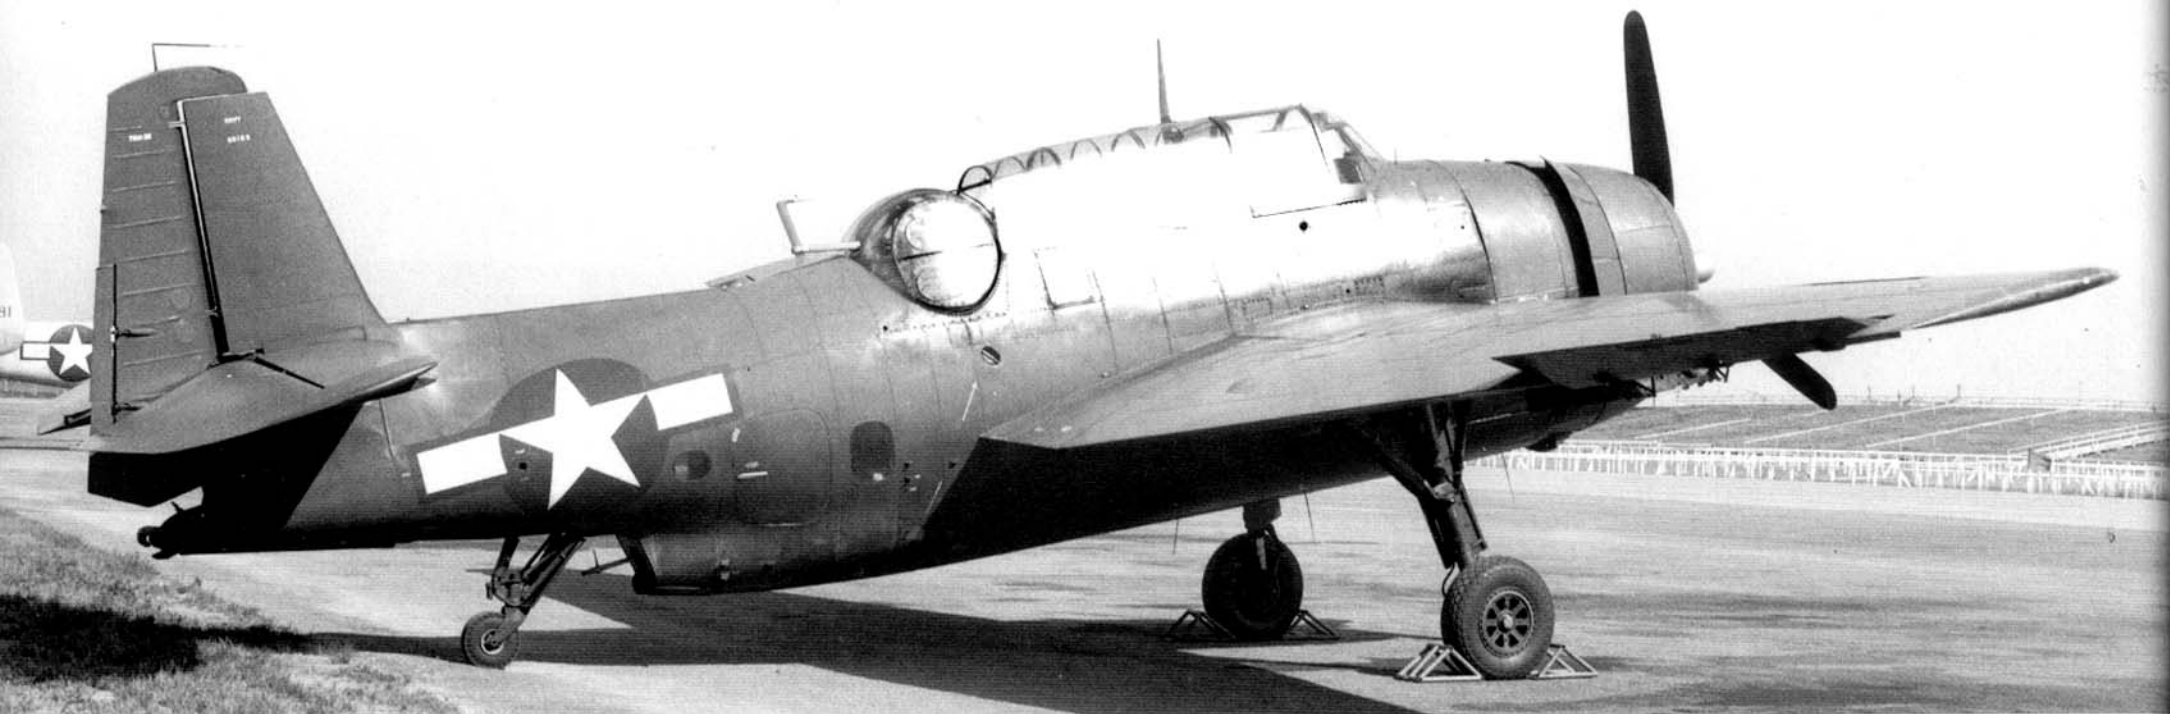
(Below) This restored TBM-3 was equipped with a replica .30 caliber machine gun in the ventral position. The TBM-3M model usually deleted the 'stinger' and the windows found in earlier models; this aircraft lacked the ventral side windows. The .30 caliber Colt-Browning M2 machine gun had a cyclic rate of 1200 rounds per minute and a muzzle velocity of 2800 feet (853.4 m) per second. (Glen Phillips)

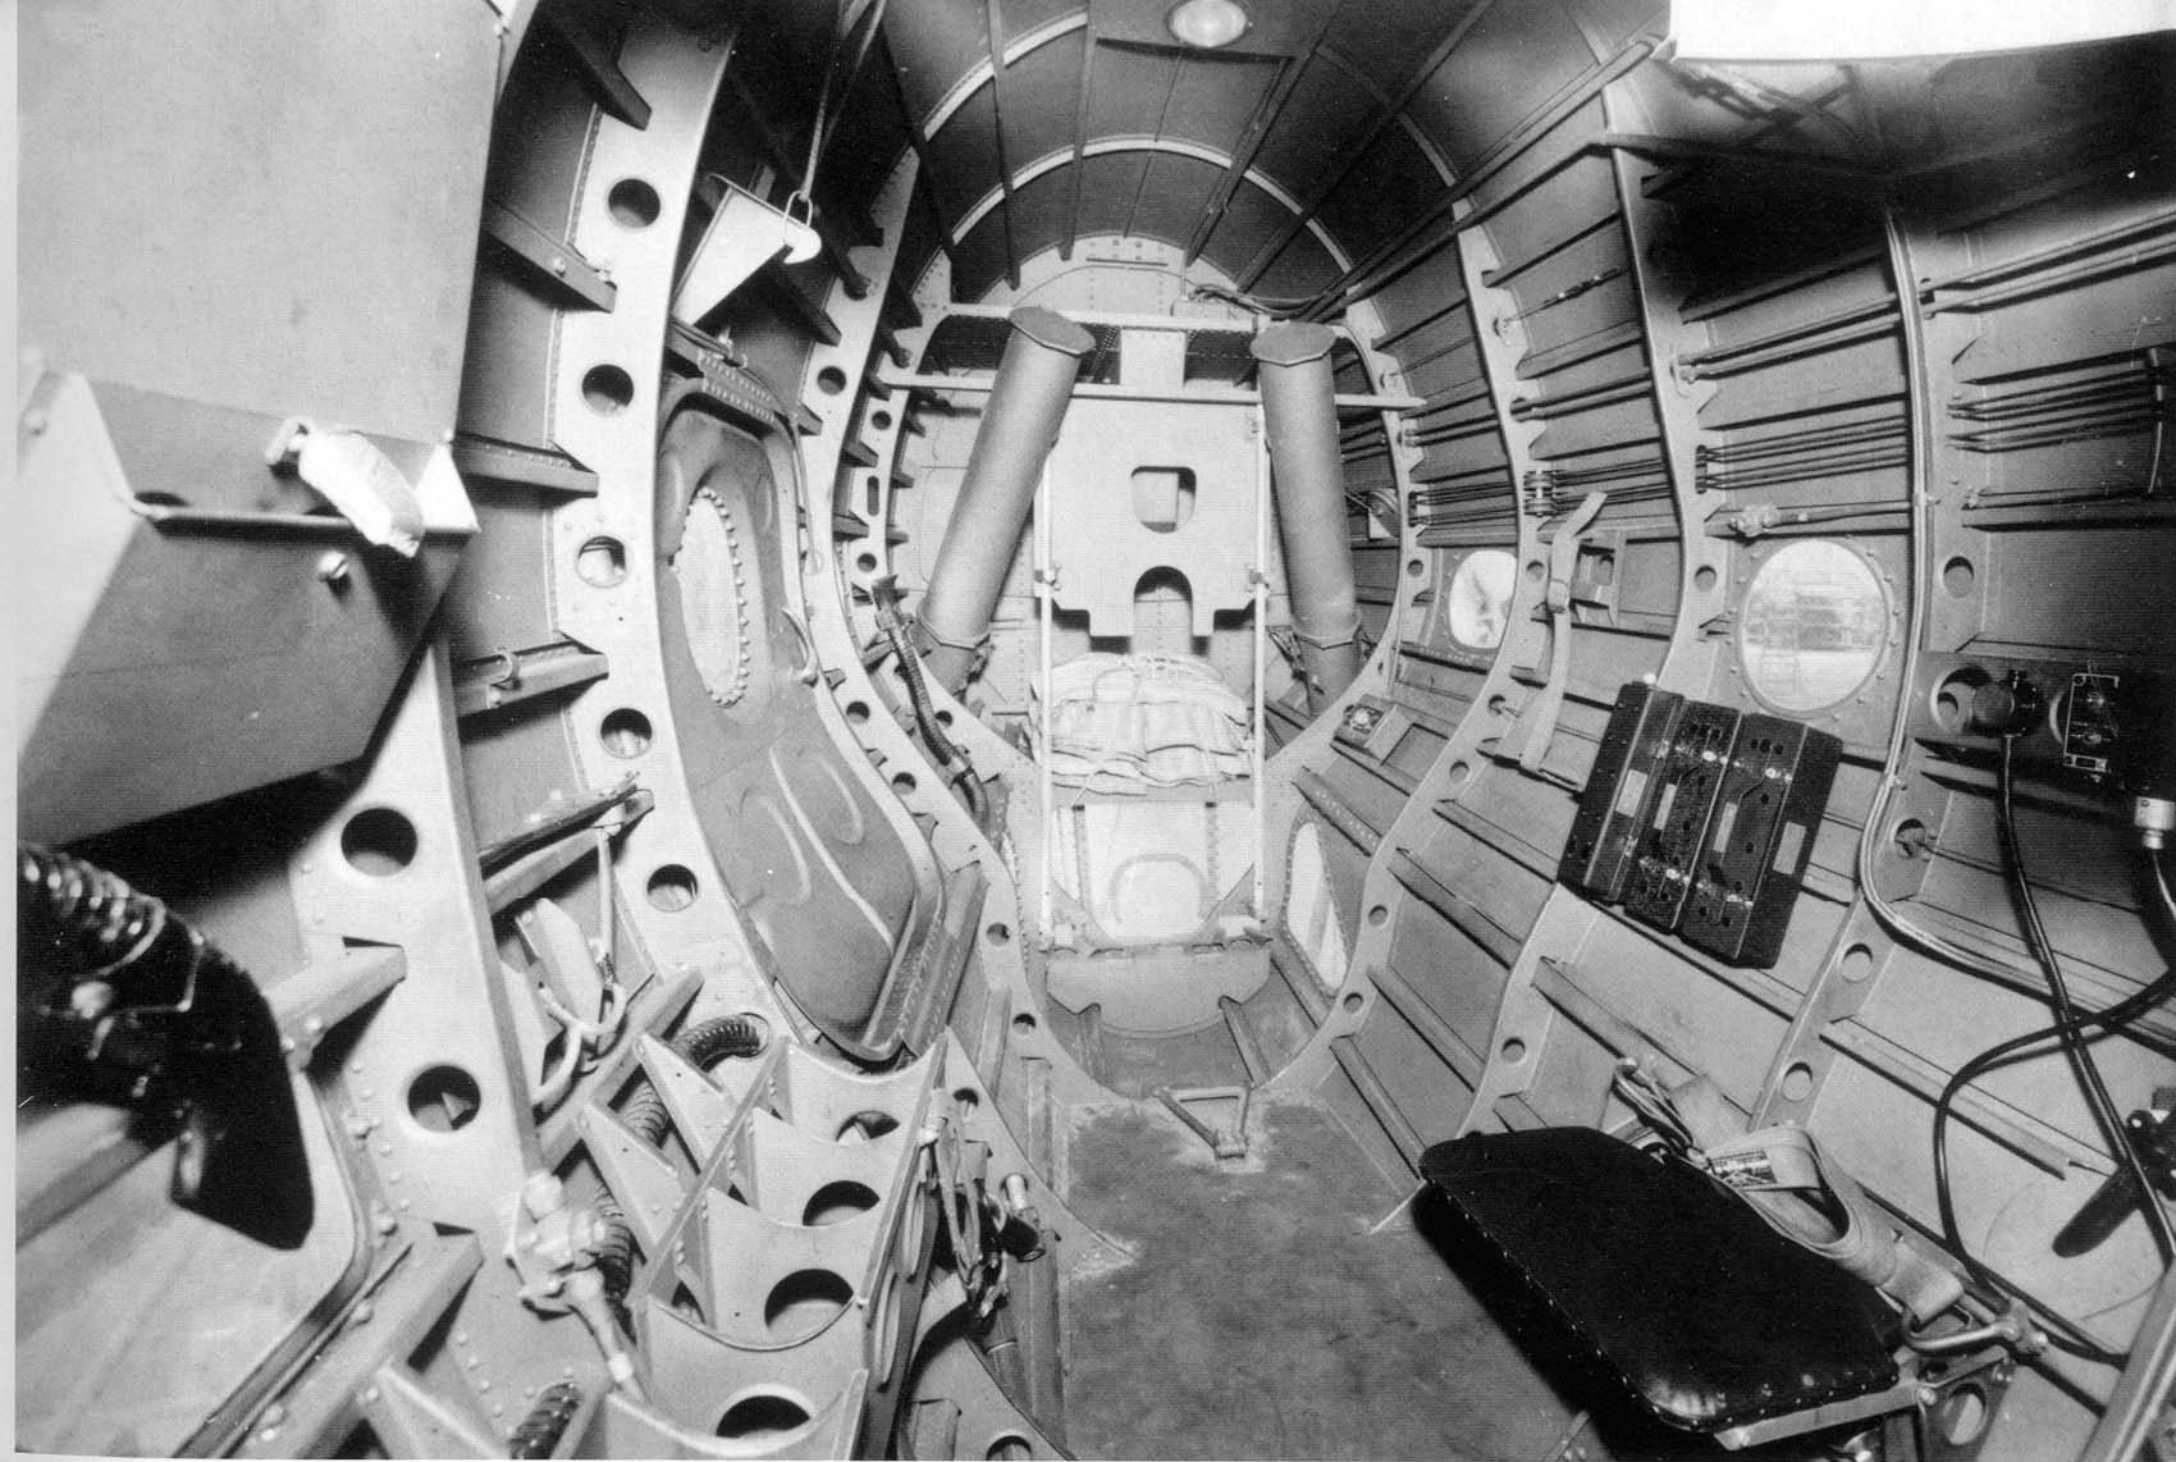
The TBF-1's ventral gun position was placed aft of the bombardier's station; this arrangement was retained in later Avenger models through the TBM-3M. The bombardier's seat was mounted on the port side on early Avengers; this was replaced with the folding seat from the TBF-1C on. The aft fuselage access door was placed on the aircraft's starboard

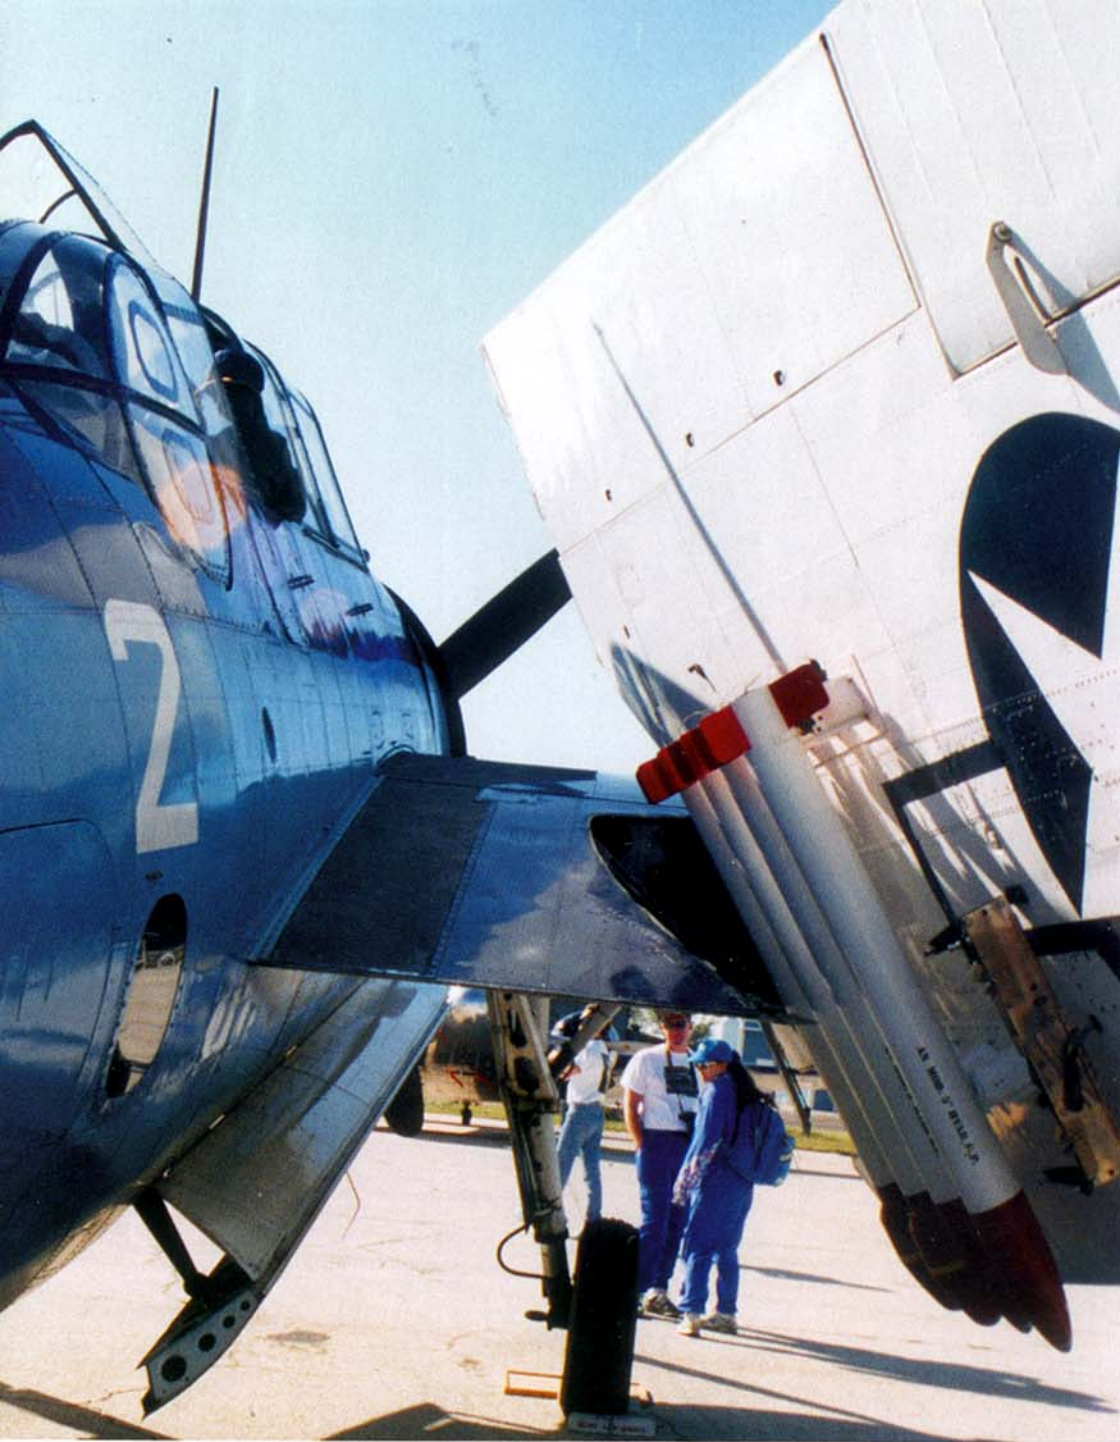
The TBF/TBM bombardier's compartment door was placed immediately aft of window on the starboard fuselage side window. Under and aft of the rear cockpit was the life raft and rescue gear storage space, which could be accessed in the event of the aircraft ditching into the water. Four replica five inch (12.7 cm) rockets were fitted to Mark 5 zero length rocket launchers under the folded starboard wing.

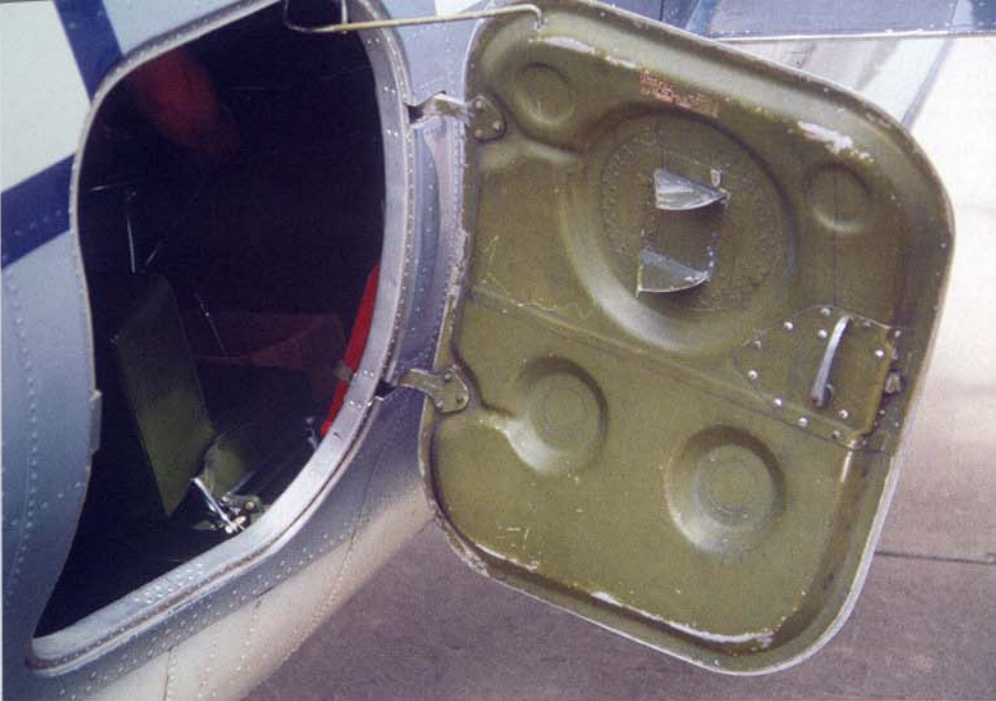
The TBF/TBM bombardier's compartment door opened forward on two flush hinges. A metal door stay was added on this restored Avenger to help the door remain open. This feature was not found on service aircraft. The bombardier/radio operator and the turret gunner could jettison the compartment door in an emergency evacuation. An emergency release lever inside the fuselage and forward of the hatch was activated to jettison the compartment door (Glen Phillips)

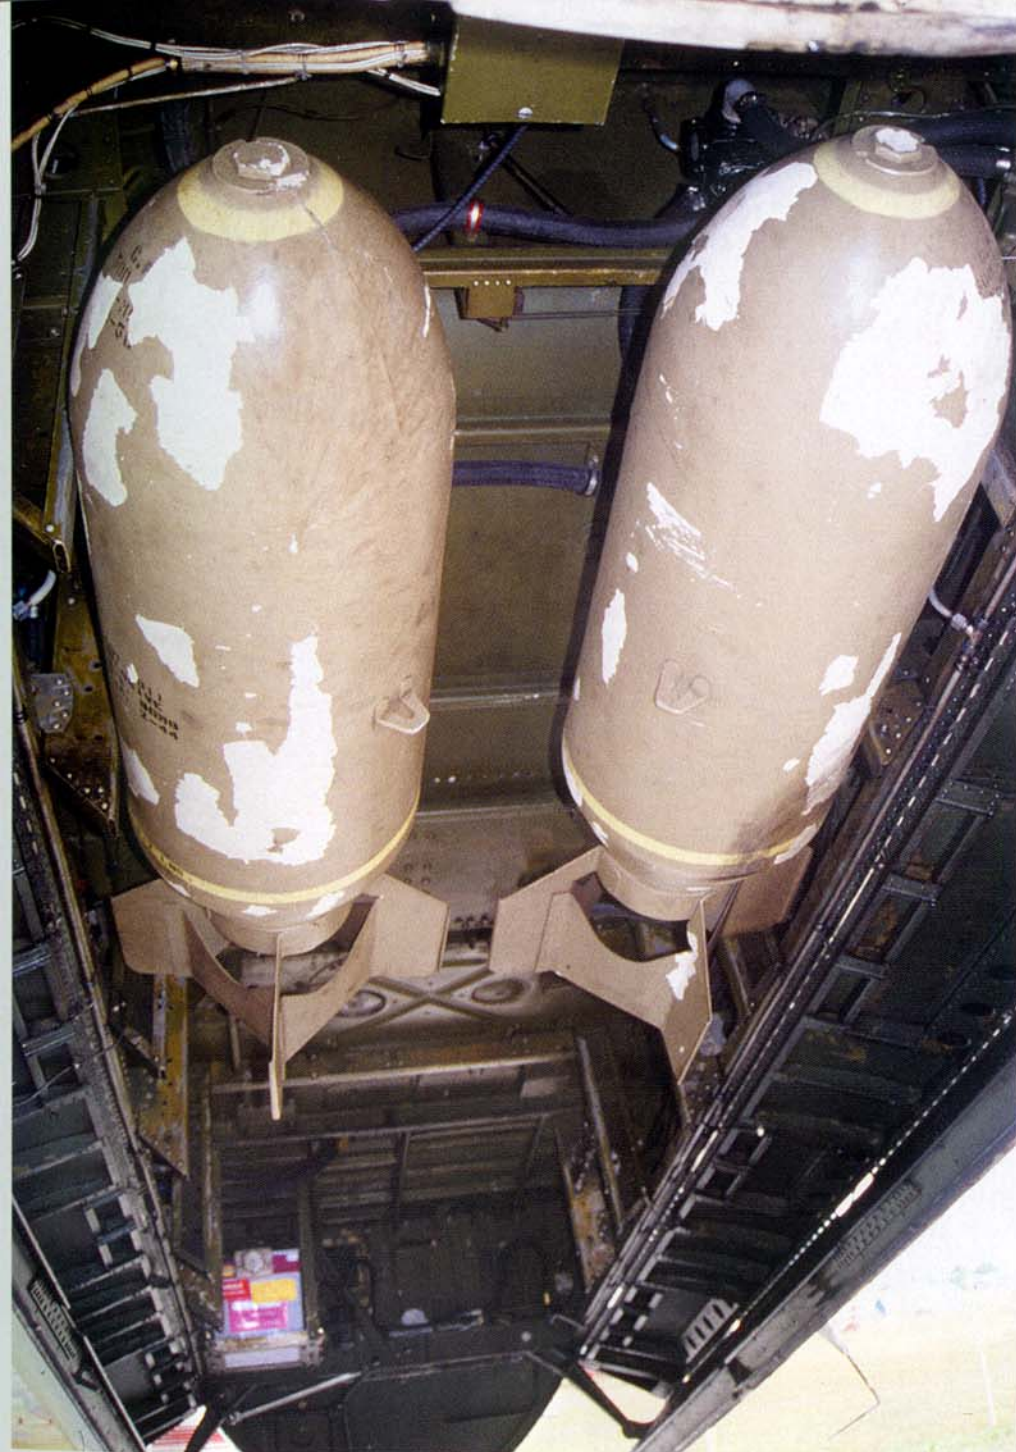
A pair of well-worn inert 500 pound (226.8 kg) bombs were mounted in a restored TBM-3's bomb bay. The bomb bay held either 12 100 pound (45.4 kg) bombs, four 500 pound bombs, one 1000 pound (453.6 kg) General Purpose (GP) bomb, or two 1000 pound Armor Piercing (AP) bombs. The Avenger could also carry either a 1600 (725.8 kg) or a 2000 (907.2 kg) pound bomb, or a 2100 pound (952.6 kg) torpedo. (Lou Drendel)

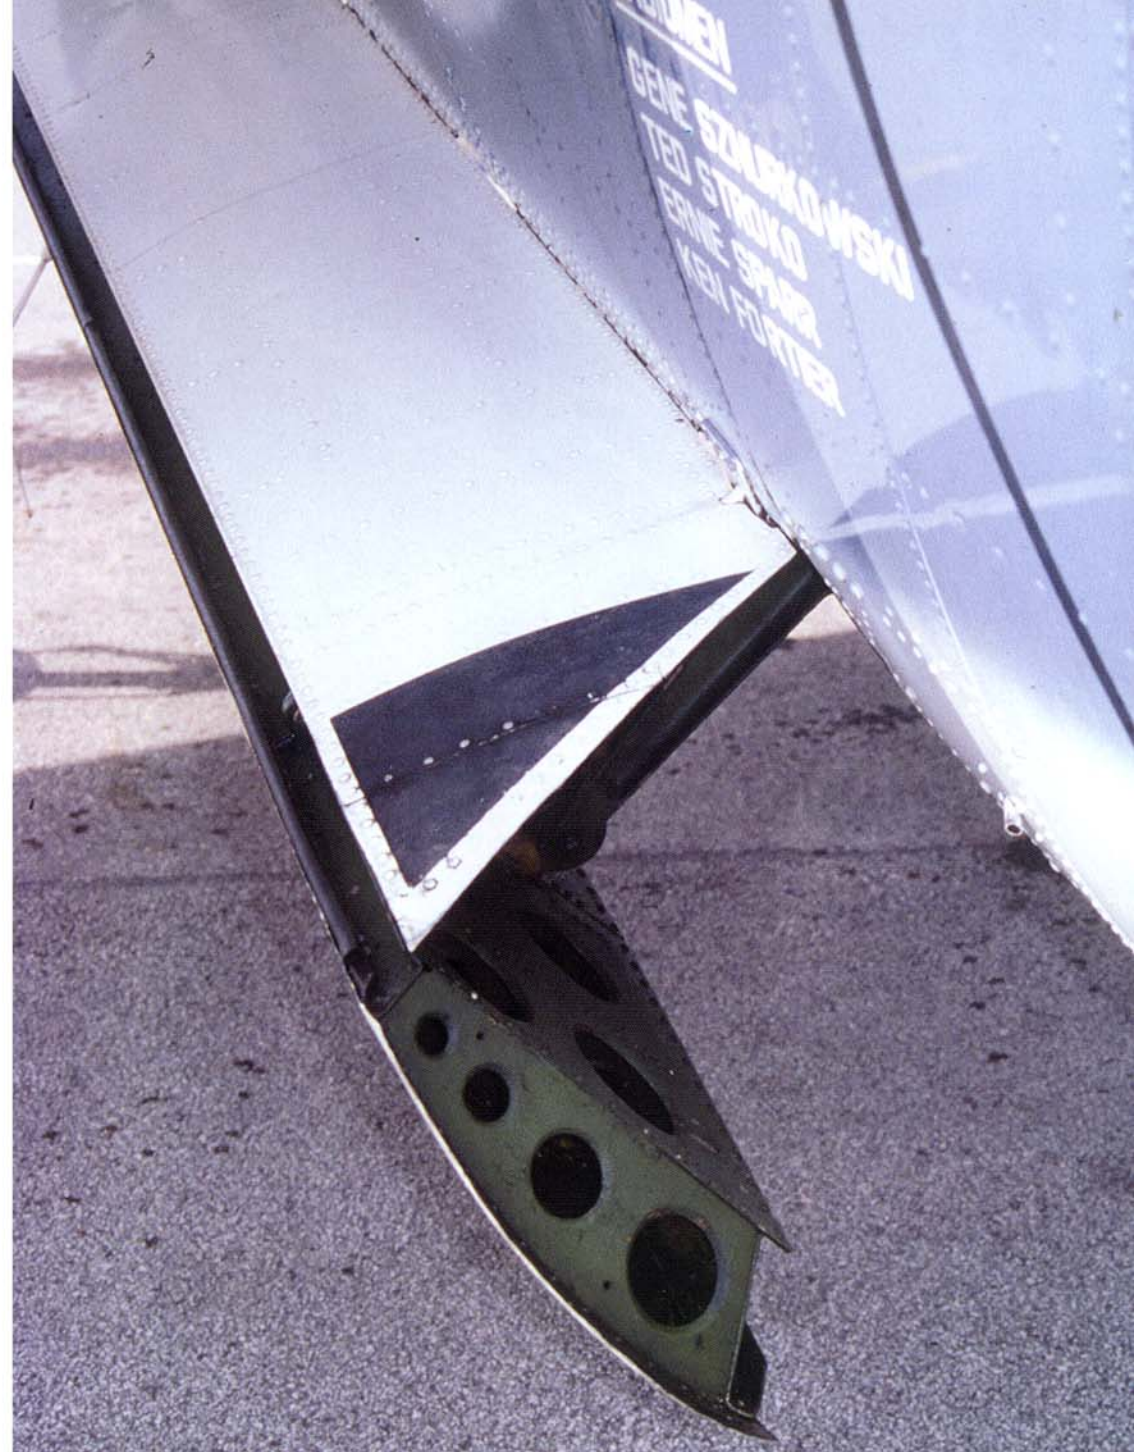
The port upper bomb bay door's aft section included an area marked as a step. This step area assisted personnel in boarding the Avenger over the port wing. All four bomb bay door sections – two each on the port and starboard sides – fit flush with the lower fuselage when the door was closed. The US Navy's 1939 requirement for a new torpedo bomber – met by Grumman's TBF – specified an internal bomb bay. (Lou Drendel)

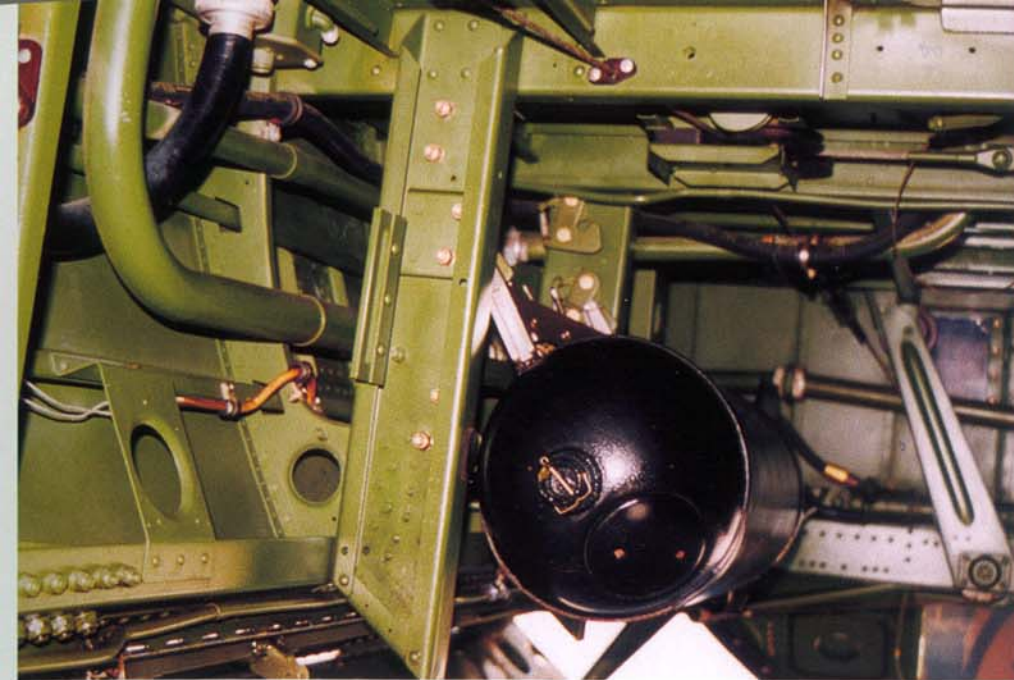
A simulated 100 pound (45.4 kg) bomb was mounted in this restored TBM-3's aft bomb bay section. The bomb is secured to a Mark 8 bomb shackle, which was installed between two vertical beams running from the bay's ceiling. Bombs were released electrically from the shackles, although manual release was available in case of electrical system failure. The Mark 8 bomb shackle became standard during TBM-3 production, replacing the earlier Mark 4 bomb shackle fitted to earlier Avenger models. (Lou Drendel)

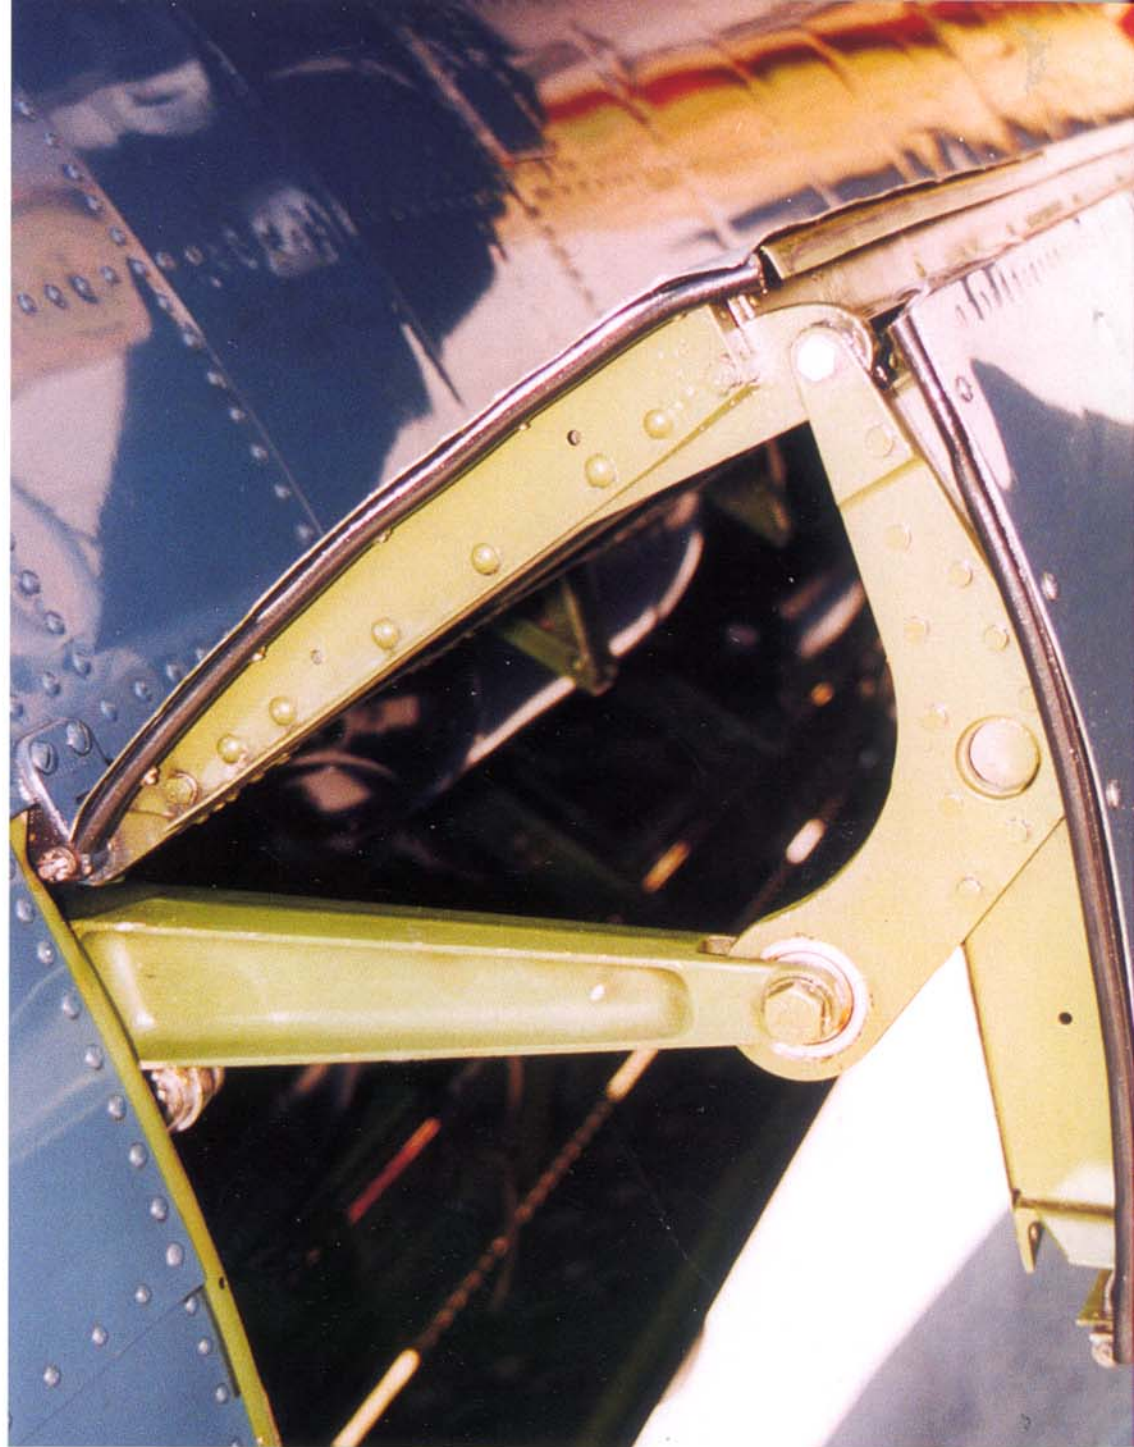
The forward bomb bay door hinge connected the lower fuselage with the inner door, while another hinge connected the inner and outer door sections. The aft bomb bay door hinge was similar in design, although modified to accommodate the angled aft door area. Rubber seals along the doors' edges kept dust and water out of the enclosed bomb bays during flight. (Lou Drendel)

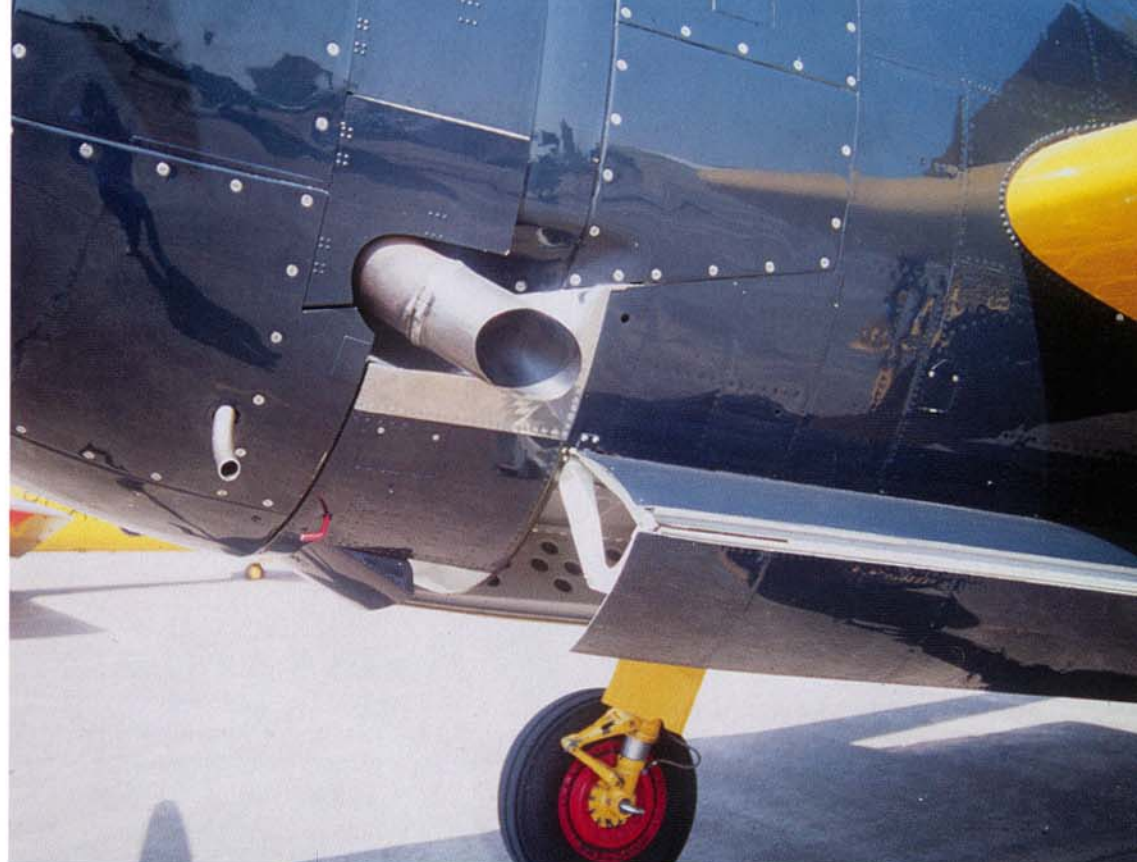
(Above Right) The bomb bay doors were opened on this TBM-3 owned by the Lone Star Flight Museum. The oil cooler vent was placed immediately in front of the bomb bay, with the port engine exhaust pipe placed above the vent. The excess oil dump vent was located on the lower engine cowl surface, ahead of and below the exhaust pipe. The bomb bay interior was painted Gloss White, which was not found on wartime US Navy TBMs. The museum's Avenger was painted in the colors assigned to utility and target tug TBMs in post-World War II service. This scheme used Glossy Sea Blue for the fuselage, with Glossy Orange Yellow (FS13538) wing and tail surfaces. The rudder and the wing bands were Glossy Insignia Red (FS11136). (Glen Phillips)

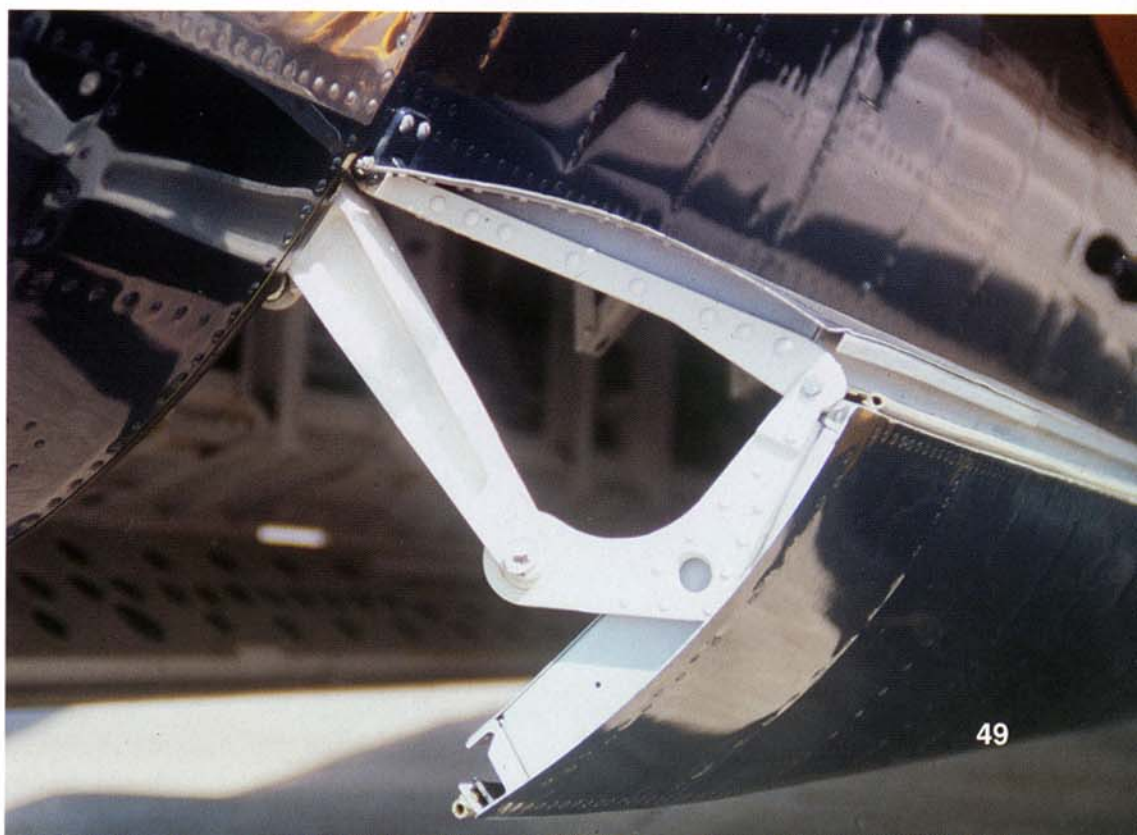
(Right) The forward bomb bay door actuating lever was connected to the inner door, which was hinged with the outer door. The aft door actuator was similar in appearance and operation. The Avenger was the US Navy's first shipboard aircraft equipped with an internal bomb bay. The Vought XTBU-1 Sea Wolf – loser to the Grumman XTBF-1 in the 1939 USN torpedo bomber competition – also had a bomb bay. (Glen Phillips)

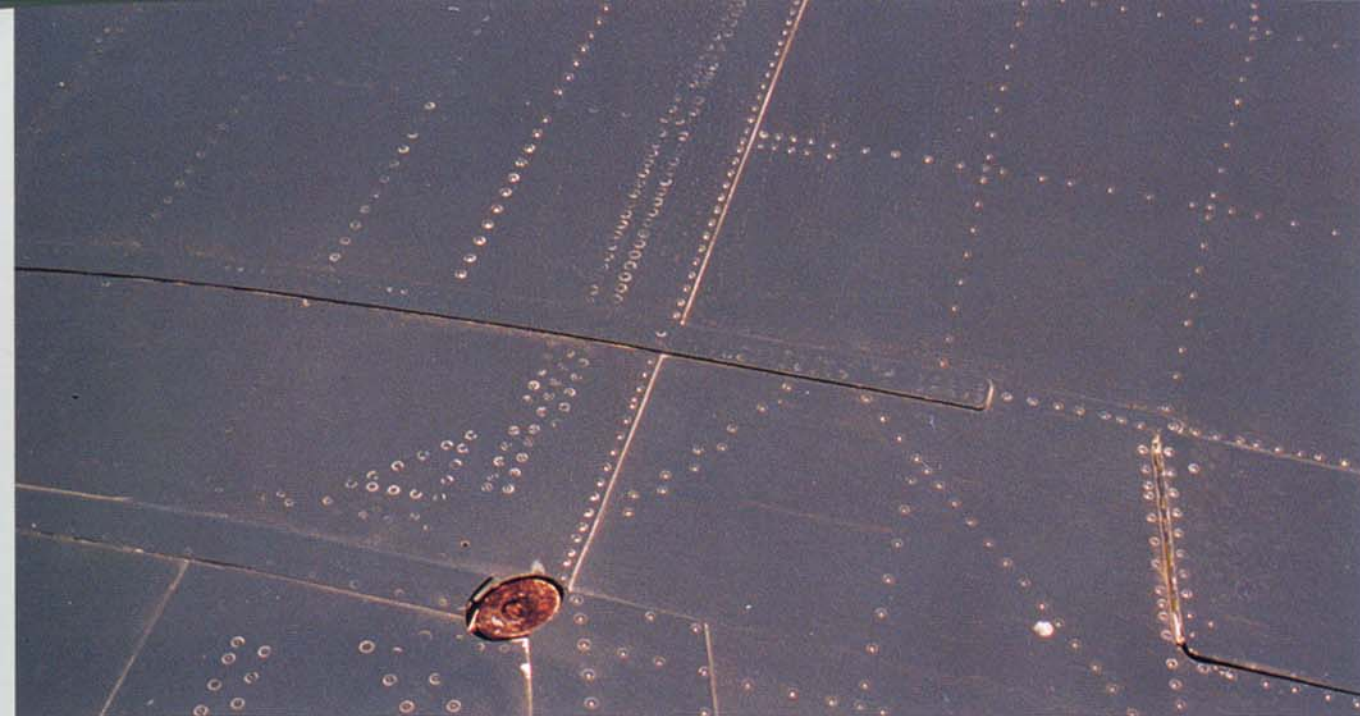
The wing fold pivot point was located approximately halfway through the Avenger's wing chord (width). This pivot was mounted to the aircraft's main wing spar for strength. A bolt was fitted within the cylindrical wing hinge filler block. A lubricator inside the bolt spread grease inside the hinge block to ensure its smooth operation. The outer wing sections rotated 90° along the pivot point to fold back along the fuselage sides. Steel flush screws lost their paint coverage after much unscrewing and rescrewing and displayed corrosion in comparison to the painted aluminum surface. (Lou Drendel)

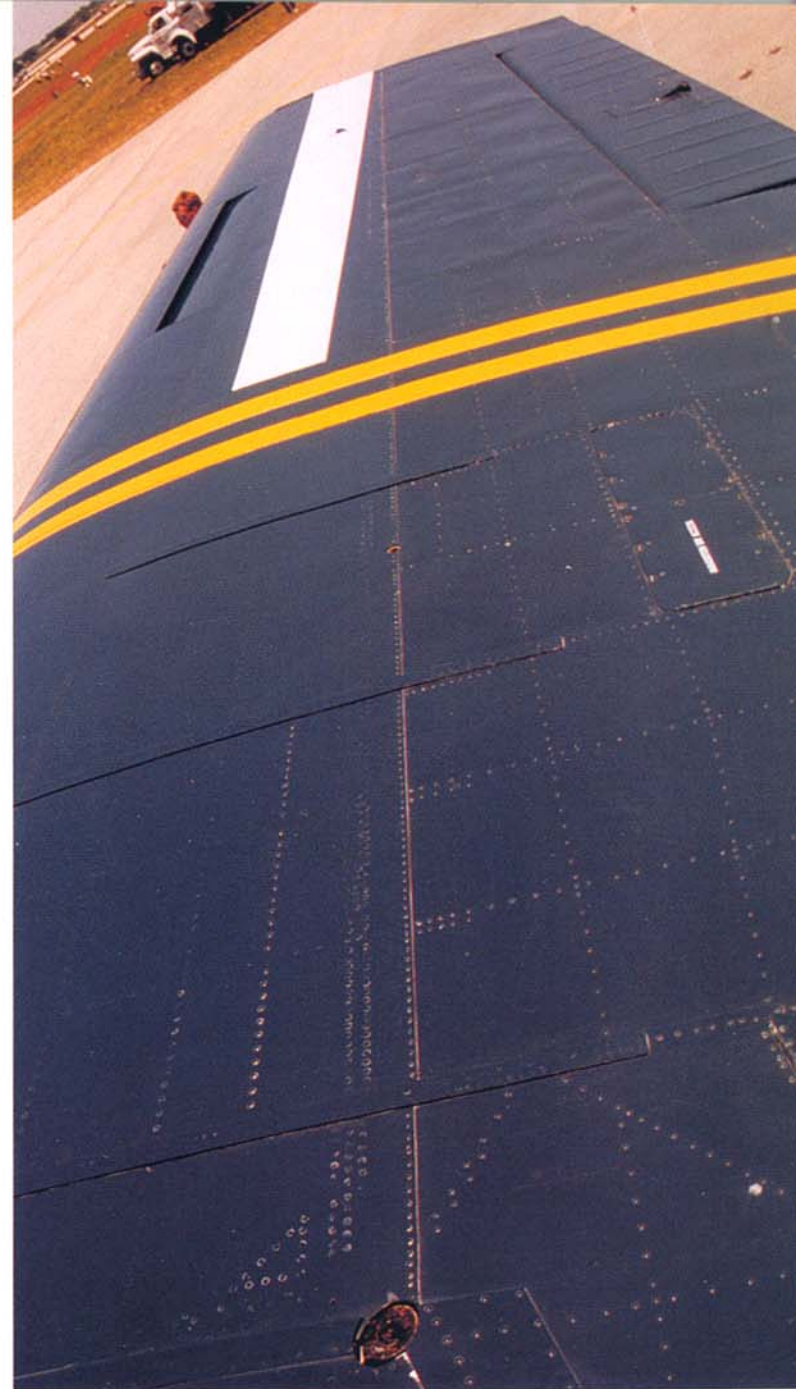
A leading edge slot was fitted to the outboard wing sections of all Avengers. This slot directed smooth airflow over the ailerons, which improved their low-speed effectiveness. Each fabric-covered aileron was equipped with an aluminum trim tab, whose actuator was mounted on the upper surface. The pilot could adjust the aileron trim tab $\pm 8^\circ$ to insure proper aileron hold under certain air loads. (Lou Drendel)
